# Appendix D

## Field Notes

Study Area: Jericho Goshen Bluewater Land Parcel# 1059 Turbine # GC 11 / SMN-9  
 Date: July 13, 2011 Start time: 10:00 End Time: 12:00 10:30

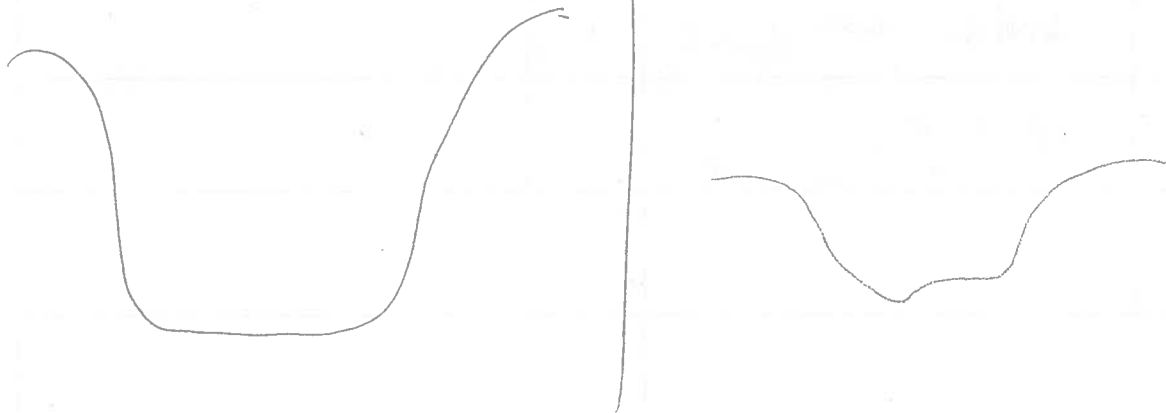
## Horizontal View of Channel

V. Step banks and shallower banks
