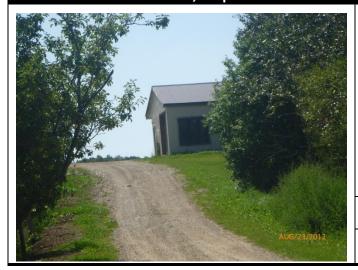
# BF#99 - 344118 North Line, Map #99

**Description** - garage with vinyl siding and small building for school bus children, and a steel sided shed. The house cannot be seen from the roadway.

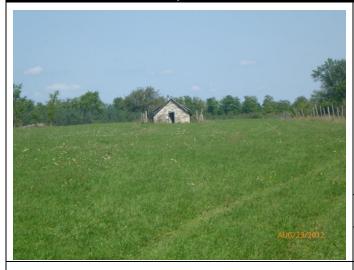
# BF#105 - North Line, Map #105

**Description** — Outbuilding, unusual in that it is constructed in stone and seemingly isolated.

Date Range - pre-1900

Potential Cultural Heritage Value or Interest (O.Reg 9/06) **Design Value or Physical Value –** none Historical Value or Associative Value - none Contextual Value – Contributes to the later 19<sup>th</sup> to mid-20<sup>th</sup> century agricultural landscape of the Municipality of West Grey

Heritage Attributes - stone structure, location associated with the fields

Mitigation Recommended – none required

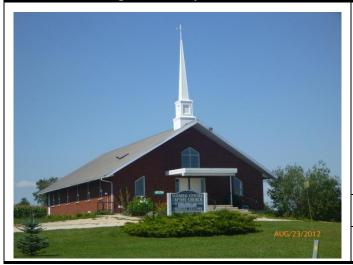
# BF#106 - Glenelg Centre Baptist Church, 493714 Baptist Church Road, Map #106

**Description** — This property contains both the residence and the church. The residence is a raised bungalow, clad in brick and vinyl, and the Glenelg Centre Baptist Church is a red brick modern construction with a central spire.

Date Range – post 1972
