APPENDIX A

CULTURAL STRUCTURES LOCATED ON OPTIONAL PROPERTIES WITH PROPOSED TURBINE RELATED ACTIVITIES

PROJECT		NEXTERA ENERGY	
ADELAIDE WIND FARM PROJECT			
TITLE			
LOCATION OF STRUCTURES FOR BUILT HERITAGE AND CULTURAL LANDSCAPE APPENDIX B			
PROJECT NO. 07-1112-0151		SCALE AS SHOWN	
DESIGN	PP	05 Mar 2008	REV 0
GIS	PP	26 Mar 2010	
CHECK	TCJR	26 Mar 2010	
REVIEW	JW	26 Mar 2010	
Golder Associates Mississauga, Ontario			Title: 1

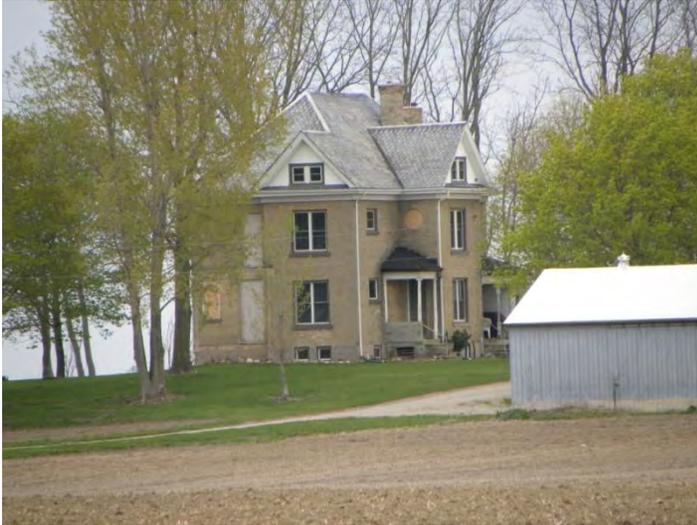
Site #27

Date: 1890s-1910

Description: Two and a half storey, brick, steeply pitched slate roof

1. Design/Physical Value: Large house
2. Historical Value: None identified
3. Contextual Value: Contributes to early 20th century agricultural activity of study area

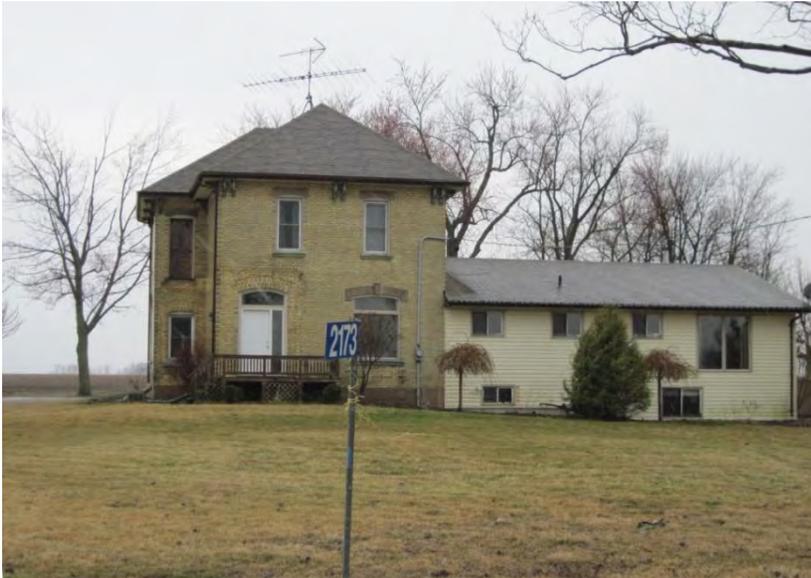
Site #28

Date: c. 1870's-1880's

Description: Similar to Site #1; paired brackets modern roof; large modern addition at rear

1. Design/Physical Value: Large house, in good condition; brackets are prominent; exterior largely unaltered except for removal of porches.
2. Historical Value: Indicative that original owner had been prosperous
3. Contextual Value: All farm buildings new

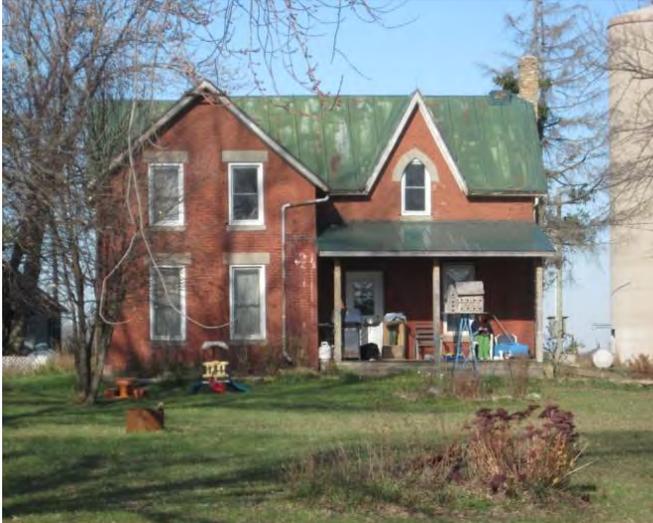
HOUSE

Date: c. 1860-1880's

Description: One and a half storey brick, "L" plan; medium pitch roof, gable end, porch on main

1. Design/Physical Value: Early use of red brick
2. Historical Value: None identified
3. Contextual Value: Contributes to early 20th century agricultural activity of study area

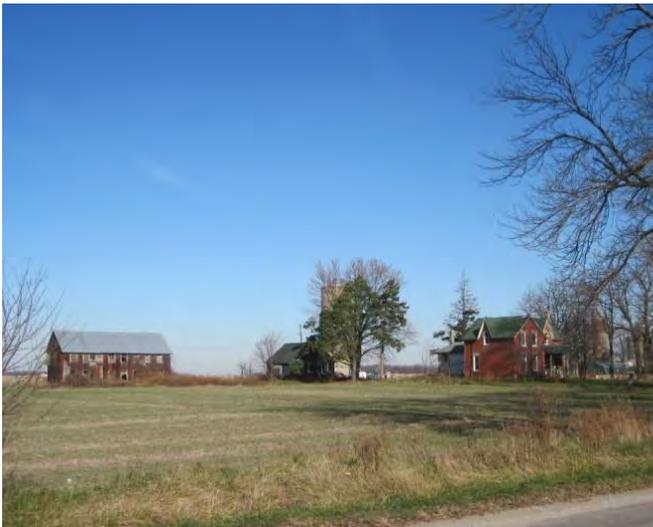
BARN

Date: early 20th century

Description: Small, two storey timber barn with multiple windows; possibly former poultry/pig barn

1. Design/Physical Value: Once popular style of barn. Many still standing in the area
2. Historical Value: Example of non-cattle barn noted in study area
3. Contextual Value: Contributes to early 20th century agricultural activity of study area

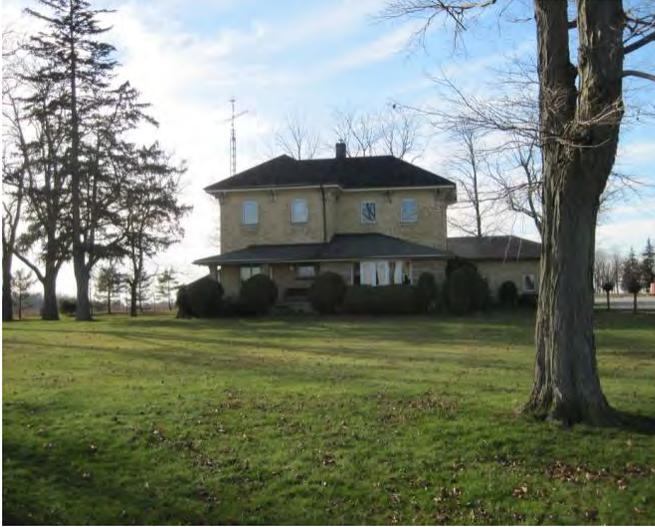
HOUSE

Date: c. 1870's-1880's
Description: Similar to Site #1; paired brackets modern roof; new porch

1. Design/Physical Value: Large house; good condition; brackets are prominent; exterior largely unaltered except for removal of porches
2. Historical Value: Indicative that original owner had been prosperous
3. Contextual Value: Contributes to early 20th century agricultural activity of study area

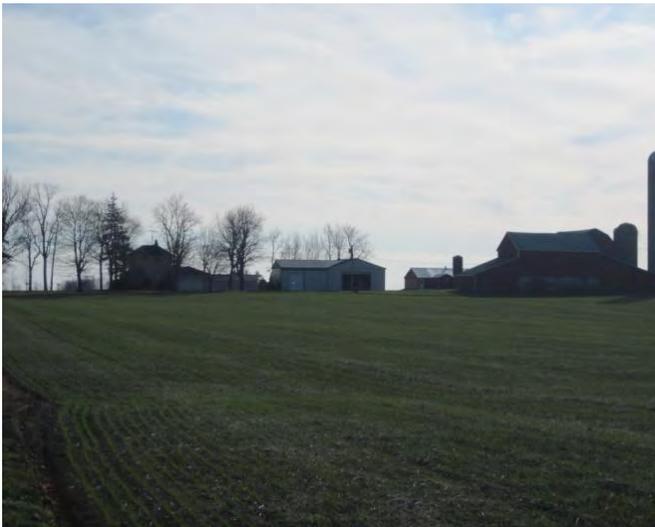
BARN

Date: late 19th /early 20th century
Description: Gambrel roof, frame barn with smaller gable roof barn

1. Design/Physical Value: Once popular style of barn. Many still standing in the area
2. Historical Value: None identified
3. Contextual Value: Contributes to early 20th century agricultural activity of study area

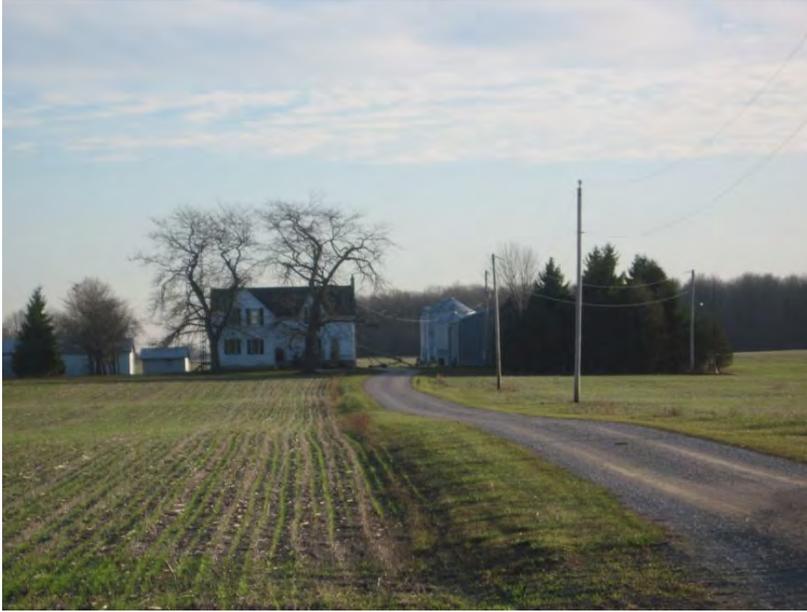
Site #32

Date: late 19th century

Description: One and a half storey “L” plan; medium pitch roof; too far from road to evaluate

1. Design/Physical Value: Unknown
2. Historical Value: None identified
3. Contextual Value: Contributes to early 20th century agricultural activity of study area

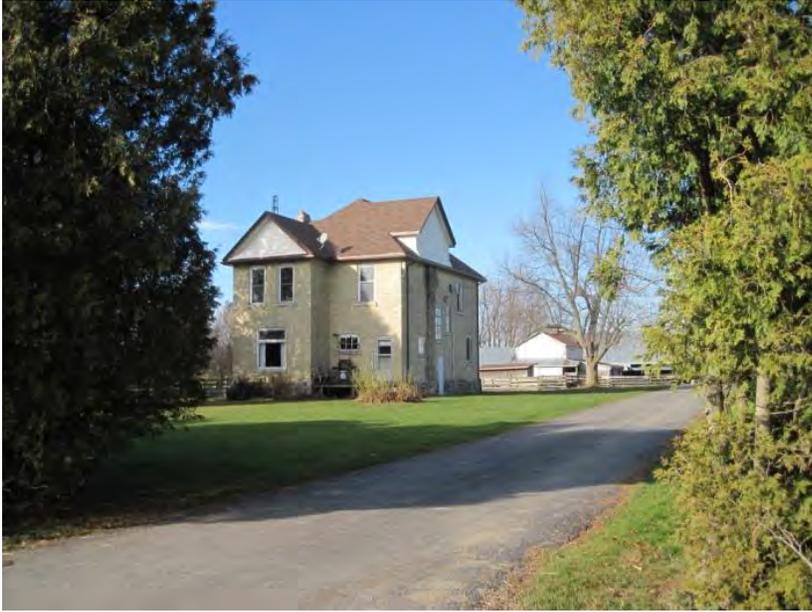
Site 33

Date: c. 1890-1910

Description: Two storey brick, steep pitch hip roof; gable end on front projection

1. Design/Physical Value: Large house; good condition
2. Historical Value: None identified
3. Contextual Value: Contributes to early 20th century agricultural activity of study area

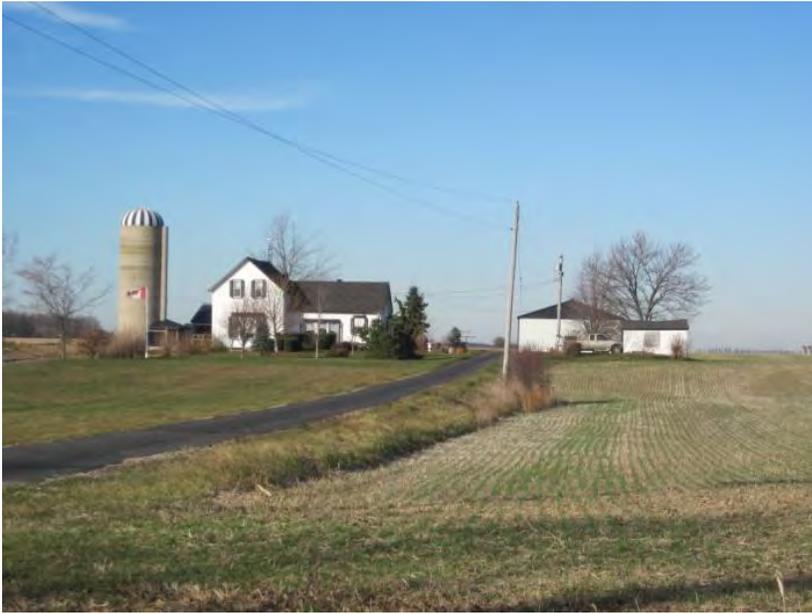
Site #34

Date: c. 1900

Description: Possible one and a half storey, medium pitch gable end roof; frame house, modern one storey addition

1. Design/Physical Value: Heavily modified
2. Historical Value: None identified
3. Contextual Value: Contributes to early 20th century agricultural activity of study area

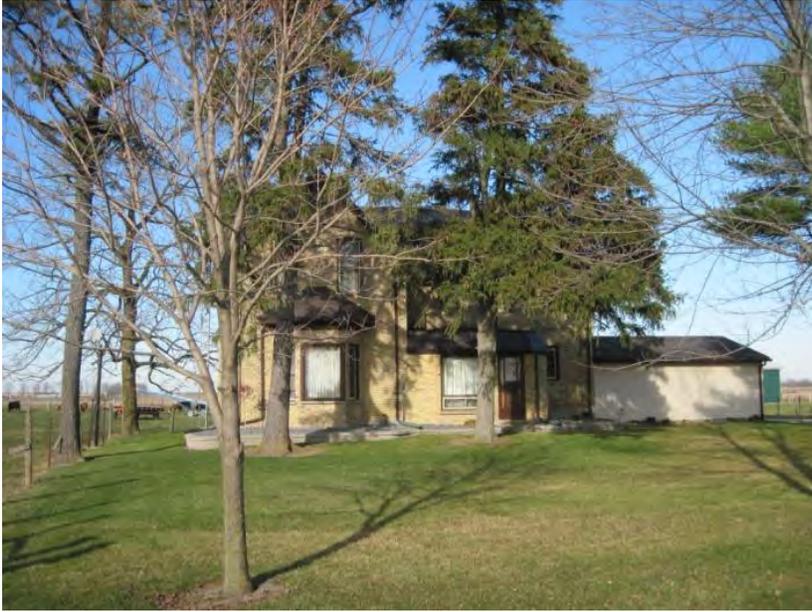
Site #35

Date: late 19th century

Description: Brick one and a half storey

1. Design/Physical Value: Not identified from road
2. Historical Value: None identified
3. Contextual Value: Contributes to early 20th century agricultural activity of study area
